<p>NCAA NAMIBIA CIVIL AVIATION AUTHORITY</p>	<p><b>REPUBLIC OF NAMIBIA</b></p> <p>NAMIBIA CIVIL AVIATION AUTHORITY</p> <p><b>AERONAUTICAL INFORMATION CIRCULAR</b></p>	<p>Executive Director Namibia Civil Aviation Authority Private Bag 12003 Ausspannplatz WINDHOEK</p>
<p>Tel: +264 61 702082 Fax +264 61 702088</p> <p>e-mail: <a href="mailto:aip@dca.com.na">aip@dca.com.na</a></p>		<p><b>AIC</b></p> <p>Series A 10/18 23 July 2018</p>

### SECTOR ENTRIES INTO INSTRUMENT APPROACH PROCEDURES

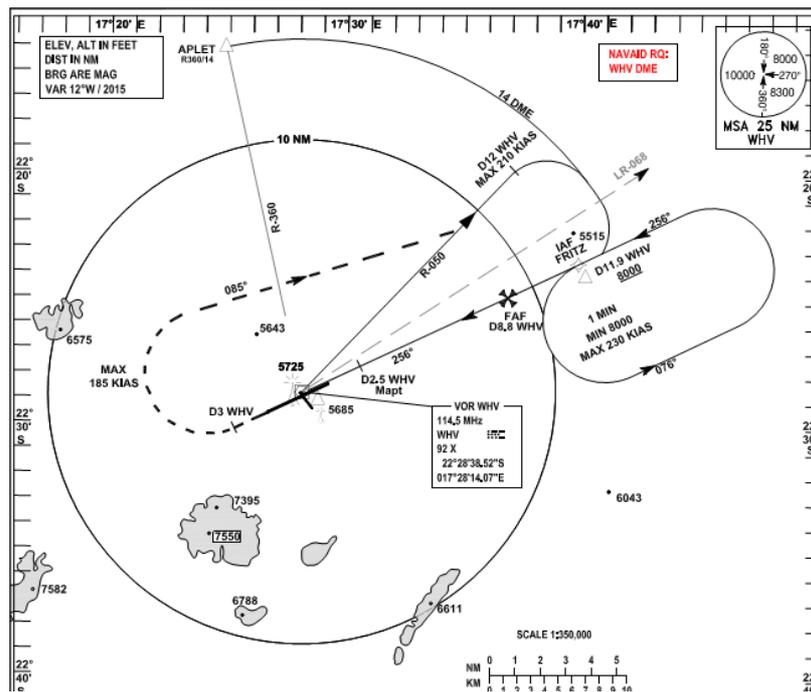
Figure 1 FYWH VOR RWY 26

7. Although there are a number of different instrument approach procedures (ILS/VOR/RNP APCH) IAF FRITZ is common to all. (refer Figure 1 next page)

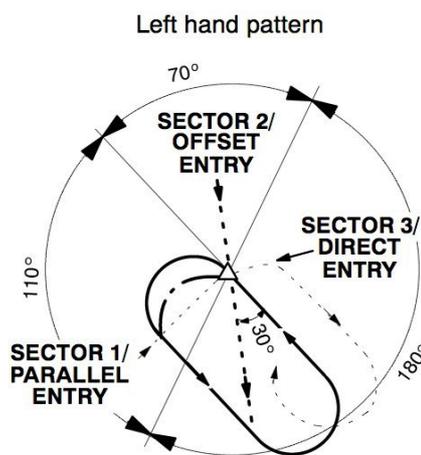
Figure 2

8. While conducting instrument approach procedures for runway 26, it has been observed that some crews are attempting to position over FRITZ without completing the correct sector entry procedure. Only when joining from the East (Sector 3 entry) or via the right-hand base from APLET or WHV R050, may an aircraft complete a direct-entry at FRITZ.
9. Traffic cleared direct to FRITZ from the North-West, West, and South-West are expected to complete an offset entry (Sector 2) or a parallel entry (Sector 1) into FRITZ depending on angle of arrival. (refer Figure 2)

10. Even if it is not expected to enter the hold (i.e. cleared for the approach from FRITZ) the sector entry must still be completed.
